# TFAWS 2015

## Thermal Coatings Seminar Series Training Part 2 : Environmental Effects

*NASA GSFC Contamination and Coatings Branch – Code 546*

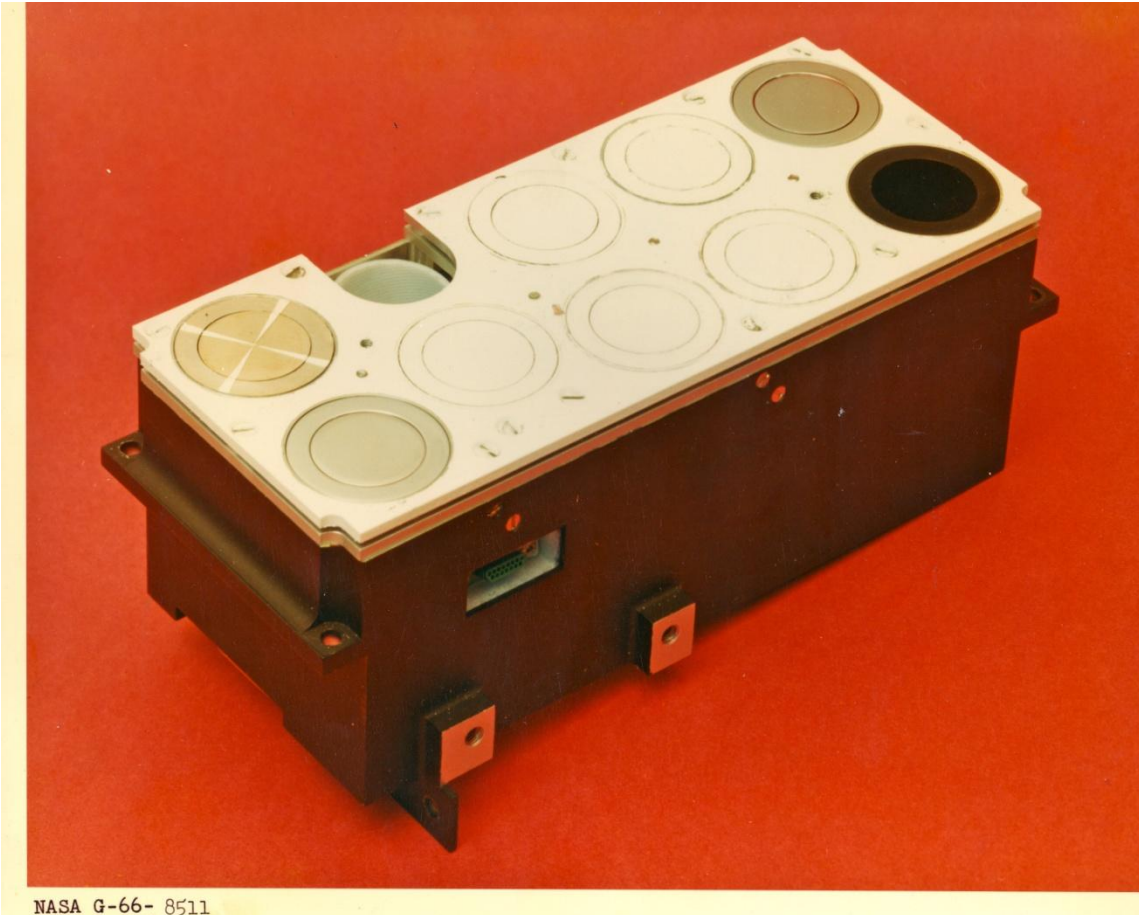
ATS-2 Coatings  
Experiment  
GEO orbit

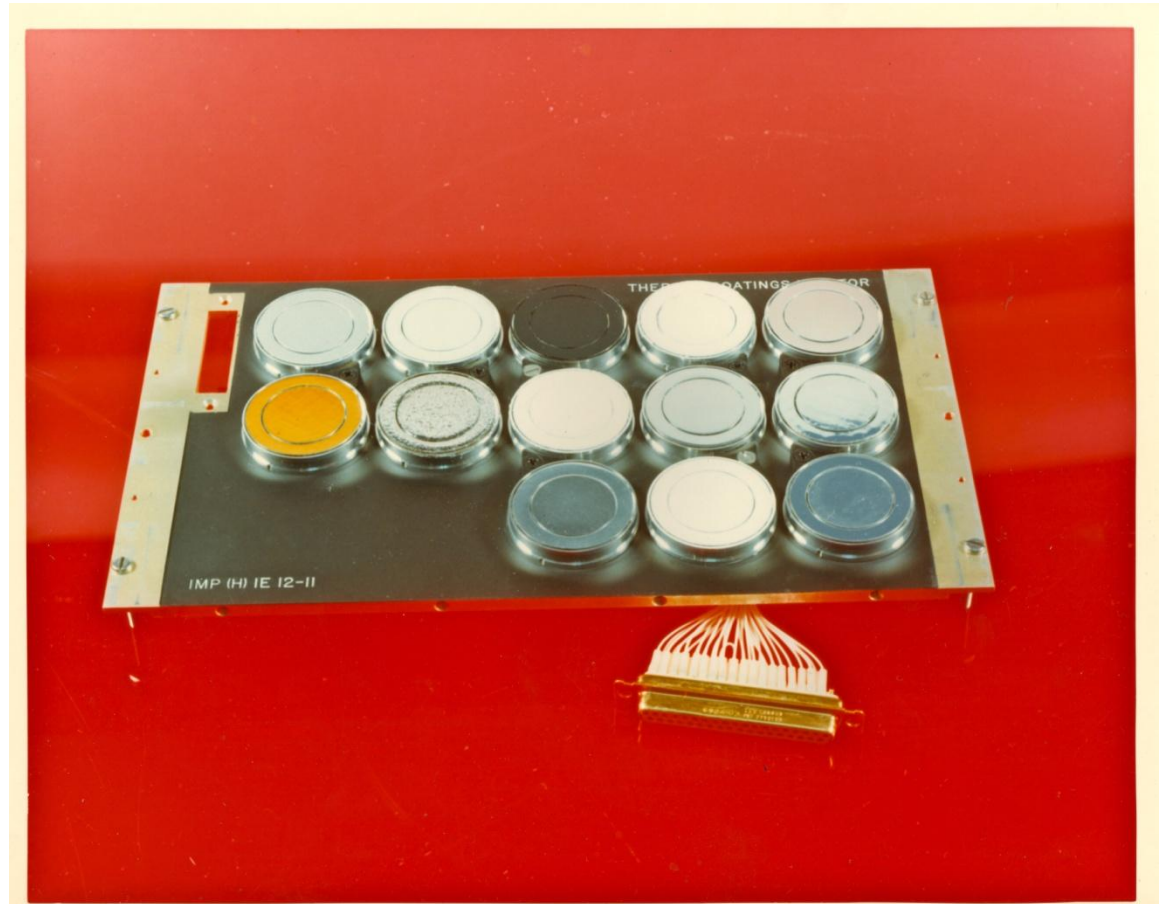
OSO-8 Coatings  
Experiment  
LEO orbit

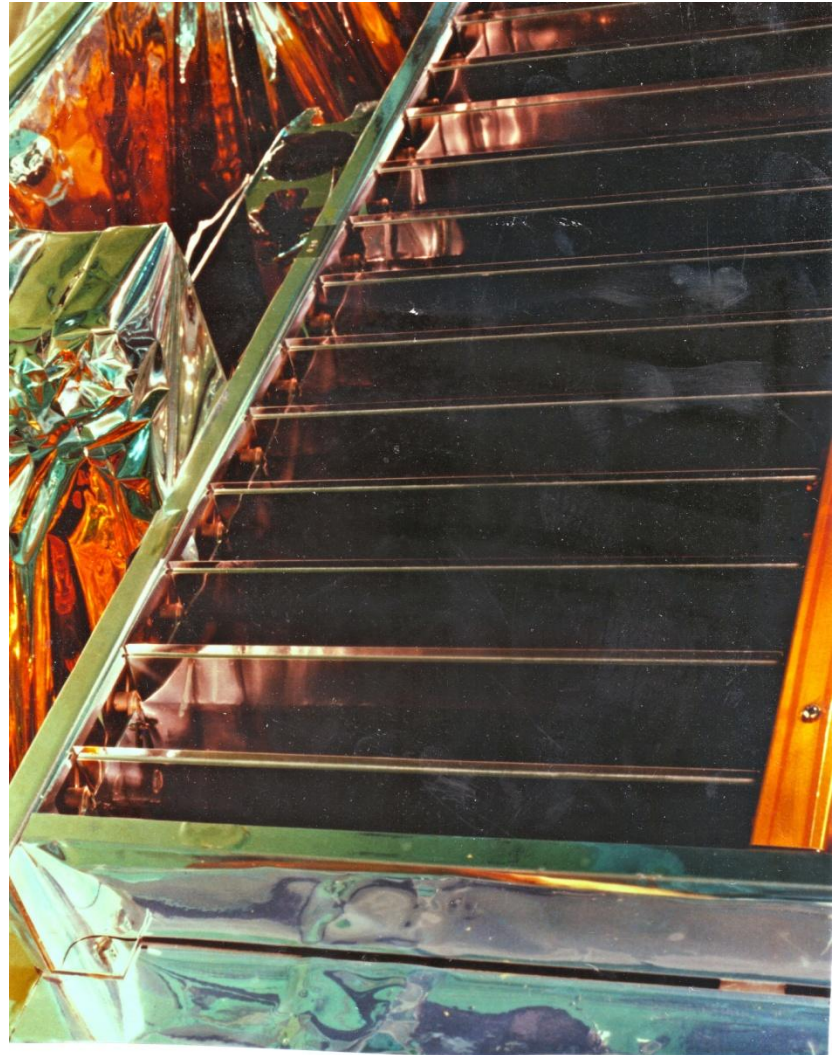
Teflon tape came separated  
from substrate

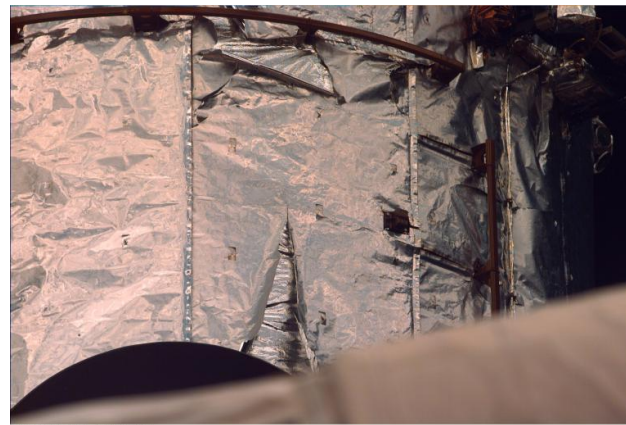
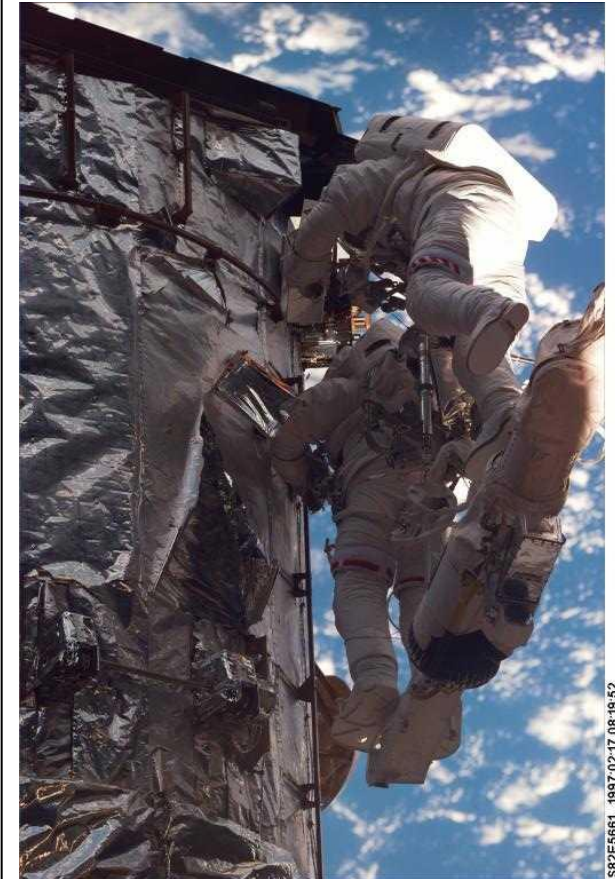
HST SM2: 6.8 years in LEO

- **HST at SM2 (6.8 years in LEO)**
  - 5-mil FEP Teflon with more than 100 cracks
- **Slow Crack Growth:** Synergistic effects of radiation (electron, proton, UV, VUV) and load (internal, blanket build and assembly, thermal cycling). Evaluated temperatures accelerates degradation.

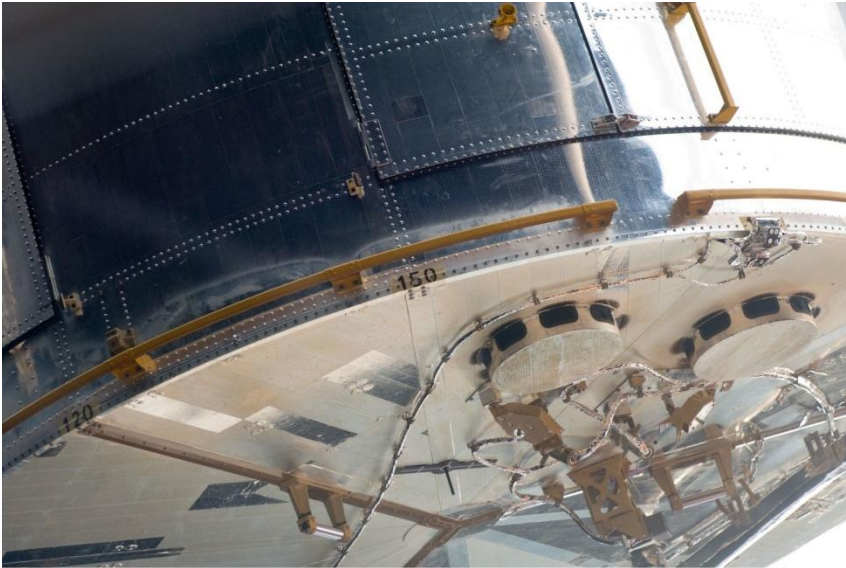
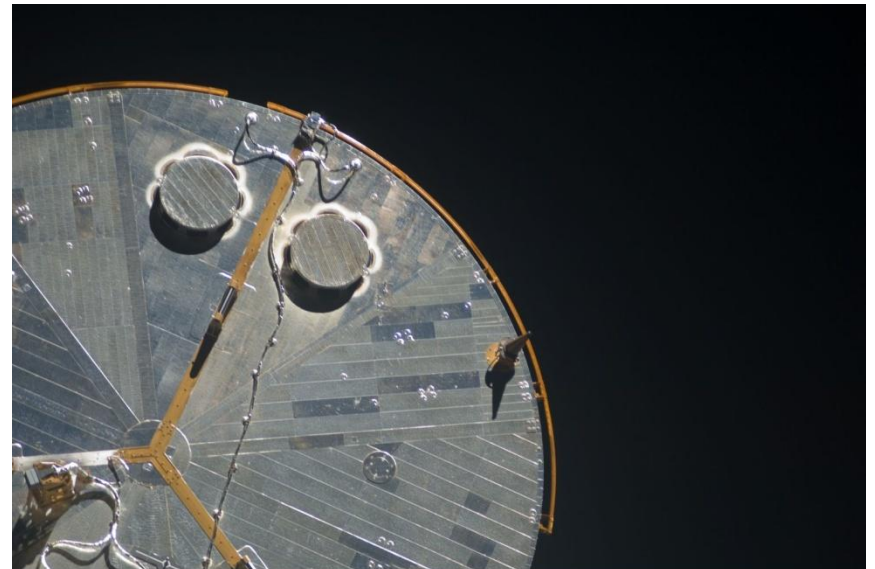
S125E006972

Adhesive bleeding  
and UV darkening

Note contamination darkening at vent  
covers
